## Injury

### Technical note

# Reverse cutting guidewire for intramedullary nailing: A solution for a common yet undocumented and unresolved complication

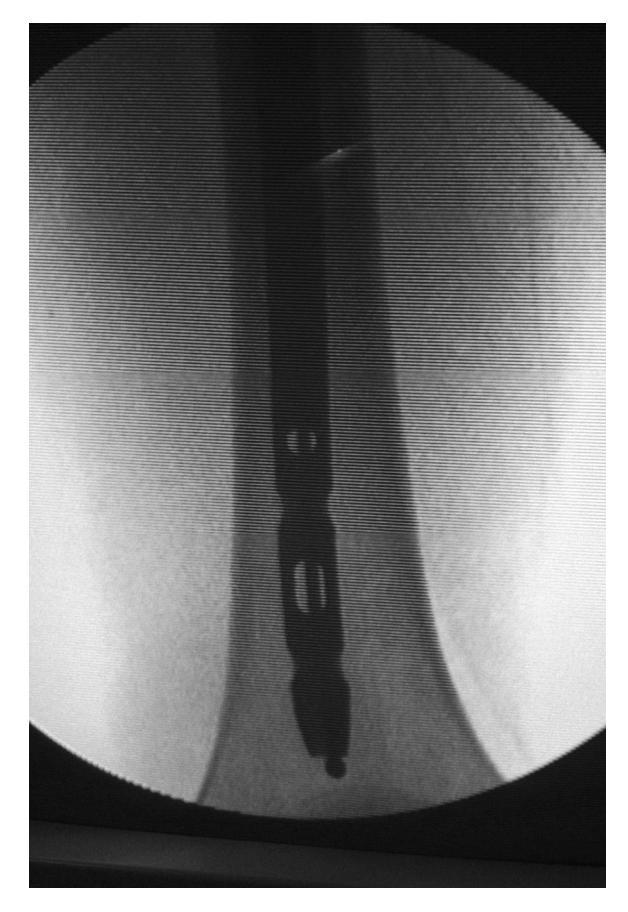
**Fig. 1.** Case 1: image intensifier image showing the ball-tip of the guidewire protruding from the femoral nail. It was impossible to withdraw the guidewire at the time.

Between September 2008 and June 2012 eighty-one patients underwent intramedullary nailing of the femur or the tibia in our institution for extra-articular fractures using the Expert femoral or tibial nail. In six cases (7.4%) the ball-tipped guidewire was impossible to withdraw by means of hand manipulation after nail insertion. In two cases hammer blows on the T-handle were successful, while in the remaining four cases the nail (one femoral, three tibial) had to be removed. Following nail removal, it was made evident that a bone fragment was incarcerated between the nail and the guidewire leaving no space for the ball-tip to withdraw through the nail (Figs. 1–4).

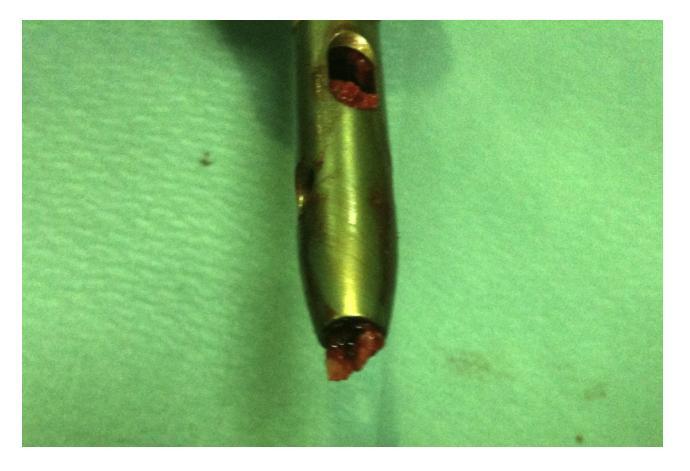
$\mbox{Fig. 2.}$  Case 1: the femoral nail after it was removed. A bone fragment is shown incarcerated at the tip.

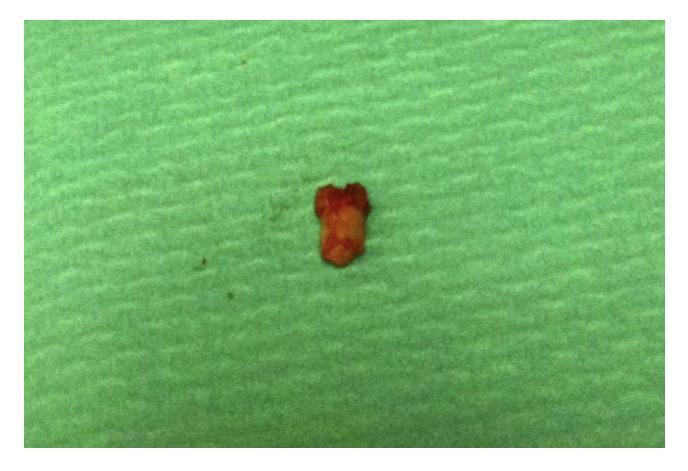
Fig. 3. Case 1: the removed bone fragment which was obstructing the ball-tip of the guidewire.

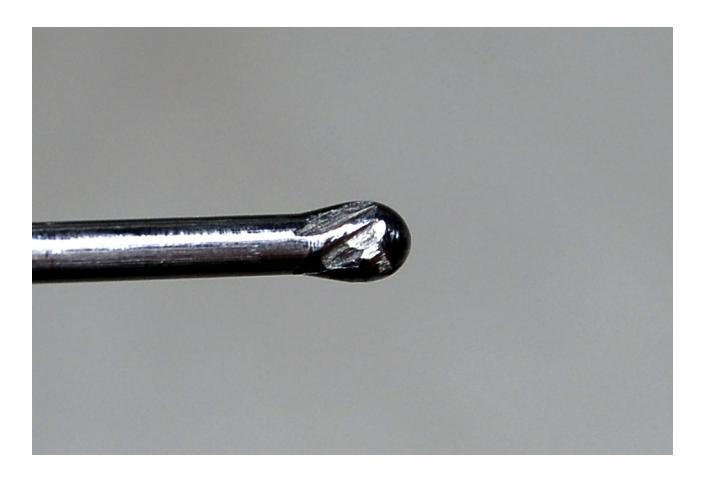
Fig. 5. Close-up image of the reverse cutting guidewire tip.

Two 3.2 guidewires were modified with the use of a high-speed rotary power tool. Using a cutting disc the smooth proximal part of the ball-tip was carved. This resulted in a reverse cutting ball-tip in a fashion similar to the cutting edges of a drill bit (Fig. 5). The direction of the cutting edges was such that clockwise rotation of the guidewire with a power tool would cut through and remove any bone fragment.

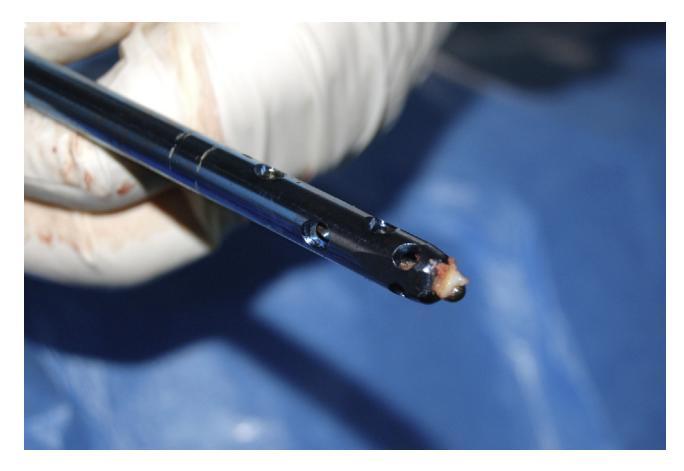
Fig. 6. The Expert tibial nail with a bone fragment impacted at the tip.

In vitro testing of the device was performed. In the first set of tests an Expert tibial nail (Synthes) 9 mm in diameter was used. A fresh arthritic femoral head which was removed from a patient during total hip replacement was used to create a bone fragment hard enough to simulate a young patient's bone. The fragment was impacted with a graft impactor between the tip of the nail and the guidewire (Fig. 6). During the first phase of the test every effort was

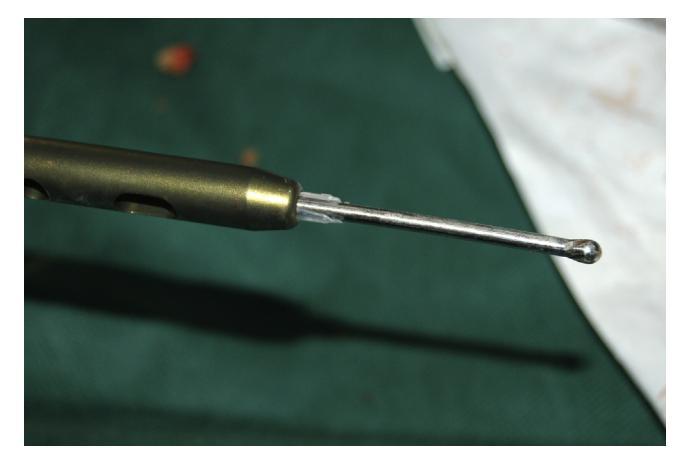
Fig. 7. The KFn femoral nail with the syringe cap in place creating a narrow canal.

In a second set of tests a KFn femoral nail (Königsee Implantate, Allendorf, Germany) with a diameter of 12 mm was used. In a similar manner a polyethylene syringe cap was impacted between the nail and the guidewire (Fig. 7). The ball-tip was impossible to pass through the narrow tip by hand or hammer blows.
