Severe metallosis following oxidised zirconium wear in total hip arthroplasty

DESCRIPTION

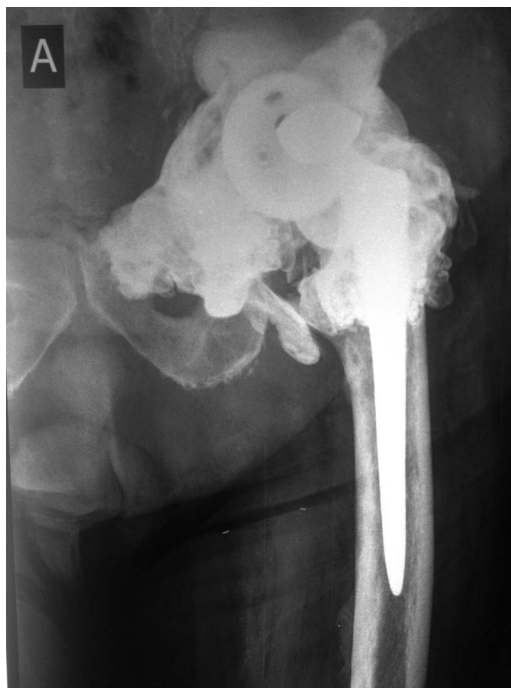
Figure 1 Anteroposterior plain radiograph, without use of contrast medium, showing an extensive cloud sign of the periprosthetic tissues, failure of the acetabular cup and wear of the oxinium femoral head.

We present a case of a man aged 81 years who underwent a primary cementless total hip arthroplasty. Eight years after the index surgery, failure of the arthroplasty was revealed by the presence of the radiographic 'cloud sign' (figure 1). The original components used were the R3 acetabular cup with a Synergy femoral stem, highly crossed linked polyethylene liner and an oxidised zirconium (Oxinium) femoral head (Smith & Nephew Synergy, Memphis, Tennessee, USA). The initial investigation included a CT scan, full blood tests and a tissue biopsy which revealed no malignancy. Subsequently, during revision surgery, there was extensive osteolysis with metallosis. There was black staining of the periprosthetic soft tissues and the hip pseudocapsule was filled with thick black fluid (figure 2). There was severe wear of the femoral head and the polyethylene liner. Following debridement and removal of the components, a revision cementless stem and acetabular cup was used to reconstruct the hip joint.

The cloud sign in the plain radiographs—also known as the bubble sign—is an indication of soft tissue metallosis.¹ The findings are usually subtle

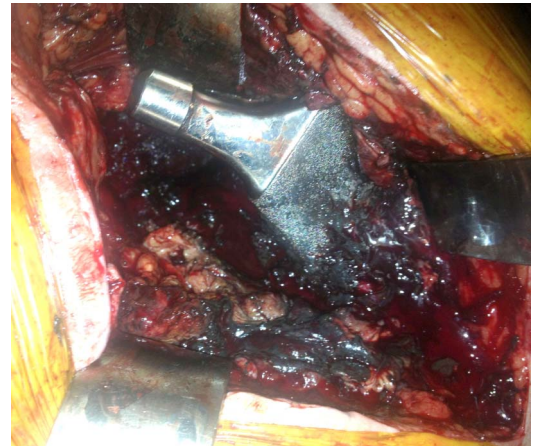
Figure 2 Intraoperative photograph during revision surgery. There is black staining of the periprosthetic tissues and osteolysis around the peritrochanteric area.
